City Works & Assets Committee

2 Laycock Street, Bexley North Condition and Compliance Assessments and Cost Plan

Client:	Bayside Council
Document:	2 Laycock Street, Bexley North Condition and Compliance Assessments and Cost Plan
Version:	Draft 1.01 – 22 February 2024
Reason for Issue:	Client Review

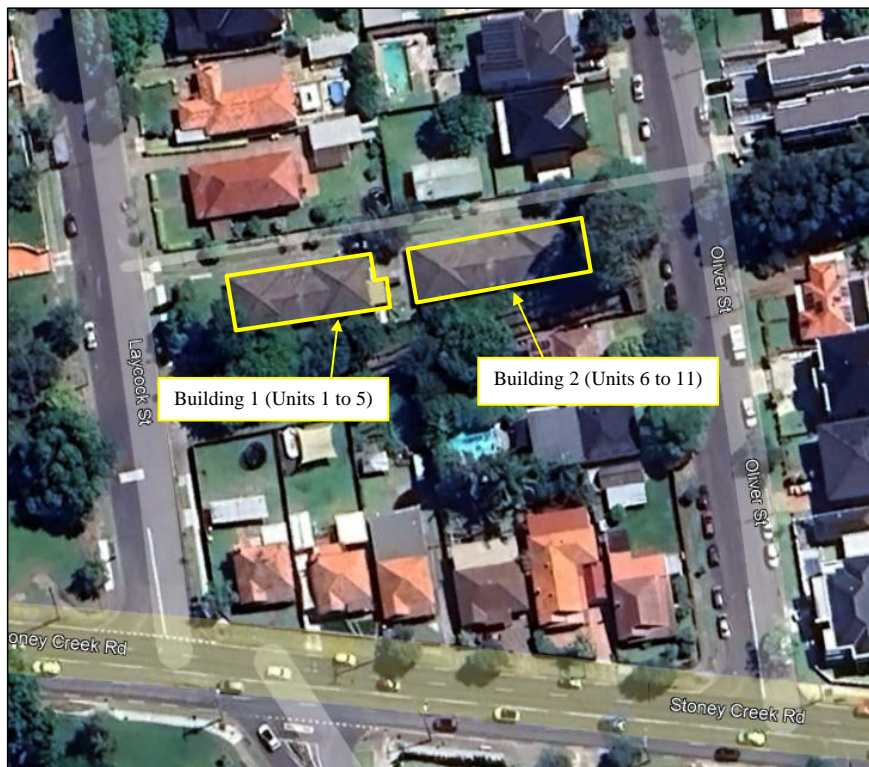
Figure 1.1 – Aerial Photo of the Residential Units

Figure 1.1 is an aerial photograph of the residential units:

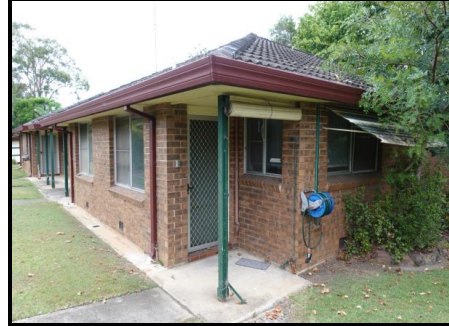
Location Photo: 01-7191

Building 1 is a single level brick construction structure on a concrete foundation. The roof structure is constructed from timber with a concrete tile roof cover. The structural elements are in fair condition with moderate deterioration. Displacement has occurred to the window frames and deterioration has occurred to the window seals.

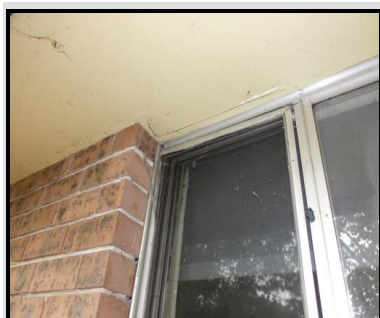
Defect ID: 120
Individual Element: Perimeter Window
Defect Description: Building 1 Exterior: Moderate deterioration has occurred to the window seals. Moderate displacement has occurred to the window frames.
Recommended Works: Replace deteriorated seals and replace displaced window frames as part of capital renewal.
Photo No.: 01-7195
Priority: High

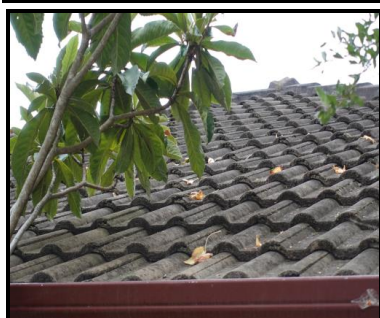
Defect ID: 119
Individual Element: Roof Cover
Defect Description: Building 1 Roof: Damage has occurred to roof concrete tiles.
Recommended Works: Replace damaged roof tiles as part of capital renewal as defect rectification.
Estimated Cost: \$380.00
Photo No.: 01-7192
Priority: High

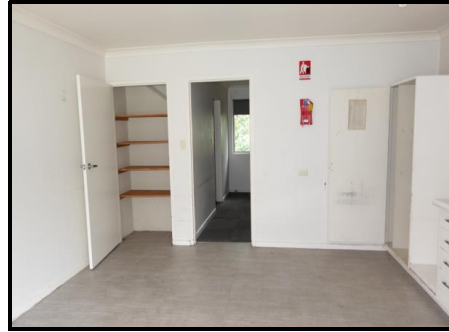
Location Photo: 01-7270

The laundry internal construction elements, finishes and fittings are in poor condition with significant deterioration. Remediation works will be required during the short term.

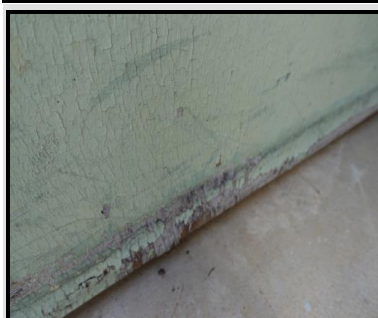
Defect ID: 199
Individual Element: Entry Door
Defect Description: Laundry: Moderate deterioration has occurred to the door.
Recommended Works: Replace the door as part of capital renewal.
Photo No.: 01-7420
Priority: Medium

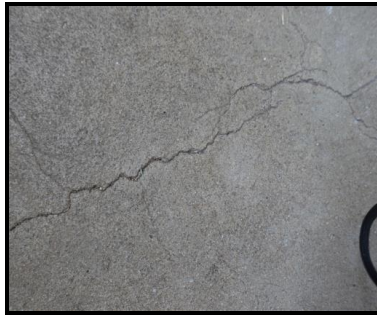
Defect ID: 198
Individual Element: Floor Construction
Defect Description: Laundry: Minor cracking has occurred to the floor.
Recommended Works: Remediate cracked sections of the floor as part of capital renewal.
Photo No.: 01-7419
Priority: Medium

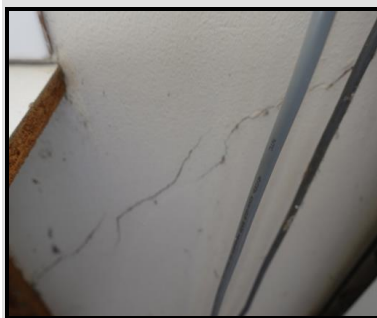
Defect ID: 195
Individual Element: Wall Construction
Defect Description: Laundry: Moderate cracking has occurred to the walls.
Recommended Works: Remediate cracked sections of the walls as part of capital renewal.
Photo No.: 01-7416
Priority: High

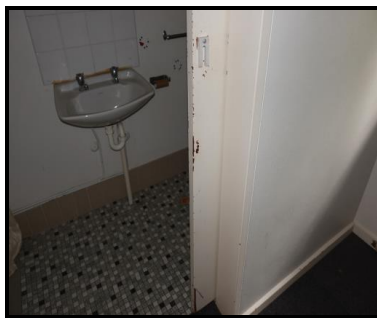
Defect ID: 143
Individual Element: Internal Door
Defect Description: Unit 1 - Bathroom: Significant deterioration has occurred to the door.
Recommended Works: Replace the door as part of capital renewal.
Photo No.: 01-7281
Priority: High

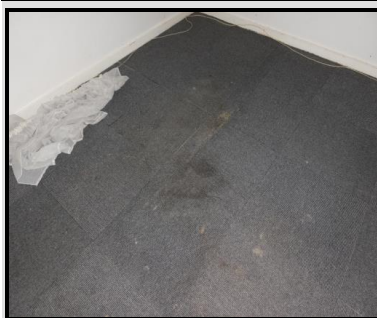
Defect ID: 148
Individual Element: Floor Cover
Defect Description: Unit 1 - Bedroom: Moderate deterioration has occurred to the carpet floor cover.
Recommended Works: Replace the floor cover as part of capital renewal.
Photo No.: 01-7291
Priority: Medium

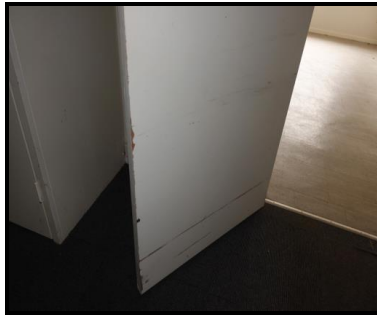
Defect ID: 144
Individual Element: Internal Door
Defect Description: Unit 1 - Bedroom: Moderate deterioration has occurred to the door.
Recommended Works: Replace the door as part of capital renewal.
Photo No.: 01-7280
Priority: High

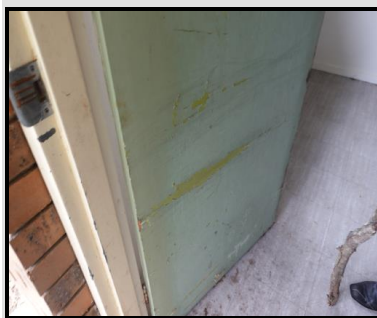
Defect ID: 149
Individual Element: Entry Door
Defect Description: Unit 1 - Entrance: Significant deterioration has occurred to the entry door.
Recommended Works: Replace the door as part of capital renewal.
Photo No.: 01-7292
Priority: Medium

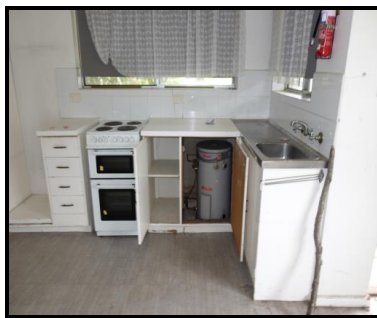
Defect ID: 139
Individual Element: Joinery
Defect Description: Unit 1 - Kitchen and Living Area: The joinery is approaching end of life.
Recommended Works: Replace the joinery as part of capital renewal.
Photo No.: 01-7272
Priority: Medium

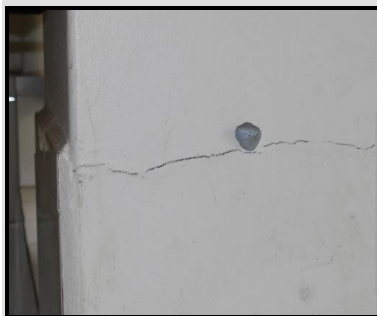
Defect ID: 147
Individual Element: Wall Construction
Defect Description: Unit 1 - Kitchen and Living Area: Minor cracking has occurred to the walls.
Recommended Works: Remediate cracked sections of the walls as part of capital renewal.
Photo No.: 01-7289-B
Priority: Medium

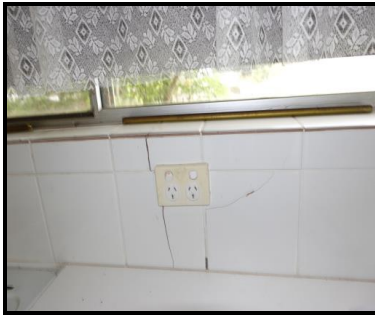
Defect ID: 145
Individual Element: Wall Finish
Defect Description: Unit 1 - Kitchen and Living Area: Moderate cracking has occurred to the wall ceramic tiles.
Recommended Works: Replace damaged tiles as part of capital renewal.
Photo No.: 01-7288
Priority: Medium

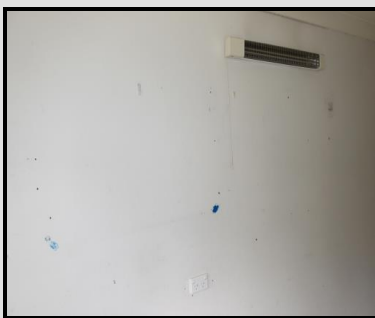
Defect ID: 146
Individual Element: Wall Finish
Defect Description: Unit 1 - Kitchen and Living Area: Moderate damage has occurred to the wall paint finish.
Recommended Works: Repaint the walls as part of capital renewal.
Photo No.: 01-7287
Priority: Low

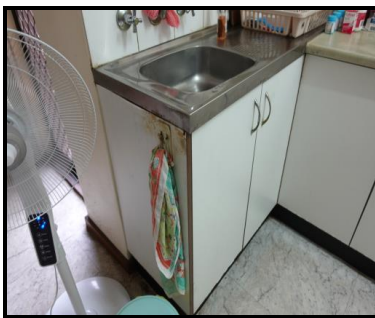
Defect ID: 137
Individual Element: Joinery
Defect Description: Unit 2 - Kitchen and Living Area: The joinery is approaching end of life.
Recommended Works: Replace the joinery as part of capital renewal.
Photo No.: 01-7240
Priority: Medium

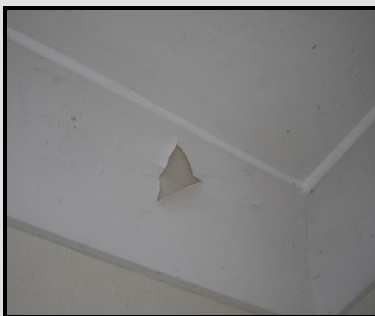
Defect ID: 151
Individual Element: Ceiling Finish
Defect Description: Unit 3 - Bathroom: Minor deterioration has occurred to the ceiling paint finish.
Recommended Works: Repaint the ceiling as part of capital renewal.
Photo No.: 01-7357
Priority: Low

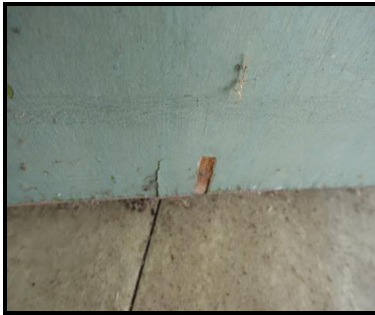
Defect ID: 152
Individual Element: Entry Door
Defect Description: Unit 3 - Entrance: Moderate deterioration has occurred to the entry door.
Recommended Works: Replace the door as part of capital renewal.
Photo No.: 01-7353
Priority: Medium

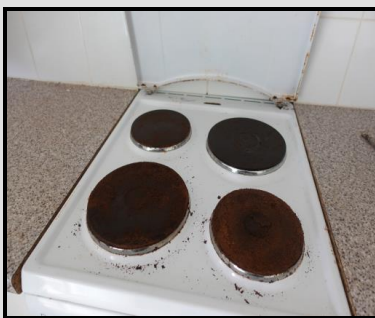
Defect ID: 153
Individual Element: Stove
Defect Description: Unit 3 - Kitchen and Living Area: The stove is approaching end of life.
Recommended Works: Replace the stove as part of capital renewal.
Photo No.: 01-7358
Priority: Medium

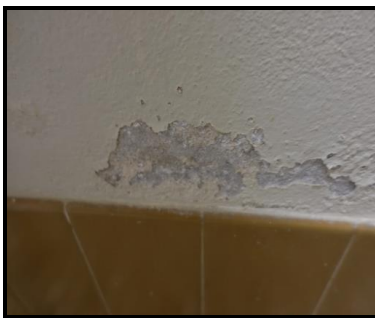
Defect ID: 154
Individual Element: Wall Finish
Defect Description: Unit 4 - Bathroom: Minor deterioration has occurred to the wall paint finish.
Recommended Works: Repaint the walls as part of capital renewal.
Photo No.: 01-7362
Priority: Low

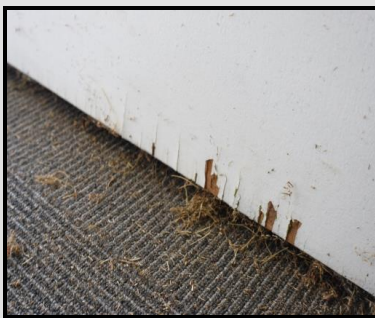
Defect ID: 155
Individual Element: Entry Door
Defect Description: Unit 4 - Entrance: Moderate deterioration has occurred to the entry door.
Recommended Works: Replace the door as part of capital renewal.
Photo No.: 01-7361
Priority: Medium

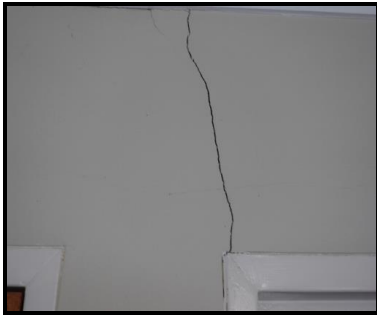
Defect ID: 156
Individual Element: Wall Construction
Defect Description: Unit 4 - Kitchen and Living Area: Minor cracking has occurred to the walls.
Recommended Works: Remediate cracked sections of the walls as part of capital renewal.
Photo No.: 01-7360
Priority: Medium

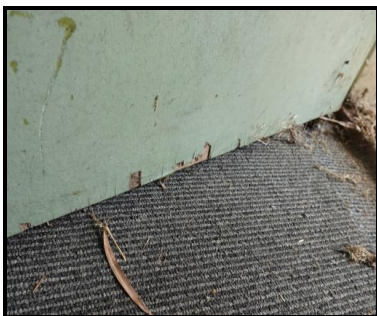
Defect ID: 159
Individual Element: Entry Door
Defect Description: Unit 5 - Entrance: Moderate deterioration has occurred to the entry door.
Recommended Works: Replace the door as part of capital renewal.
Photo No.: 01-7368
Priority: Medium

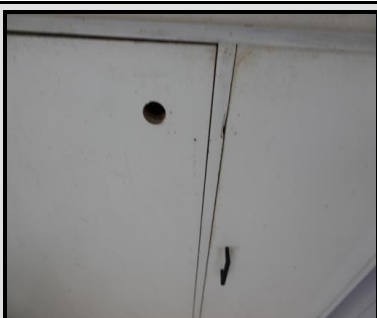
Defect ID: 158
Individual Element: Joinery
Defect Description: Unit 5 - Kitchen and Living Area: The joinery is approaching end of life.
Recommended Works: Replace the joinery as part of capital renewal.
Photo No.: 01-7371
Priority: Medium

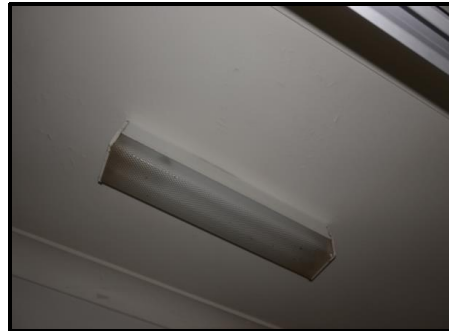
Location Photo: 01-7284

Internal lighting is provided by a combination of fluorescent, oyster and LED light fittings. The fluorescent and oyster light fittings are approaching end of life. The LED light fittings are in good condition. A ceiling light fan is installed in the unit 4 bedroom and is in fair condition.

External lighting is provided by fluorescent light fittings, which are in poor condition and will require replacement during the short term.

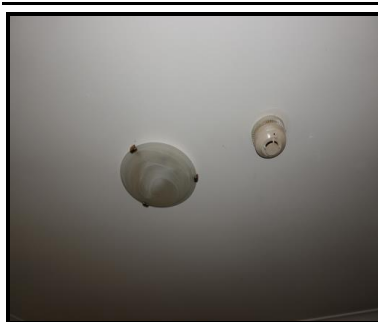
Defect ID: 142
Individual Element: Lighting - General
Defect Description: Unit 1 - Bedroom: The light fitting is approaching end of life.
Recommended Works: Replace the light fitting as part of capital renewal.
Photo No.: 01-7278
Priority: High

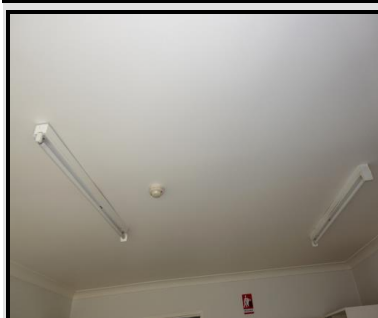
Defect ID: 141
Individual Element: Lighting - General
Defect Description: Unit 1 - Kitchen and Living Area: The light fittings are approaching end of life.
Recommended Works: Replace the light fittings as part of capital renewal.
Photo No.: 01-7271
Priority: High

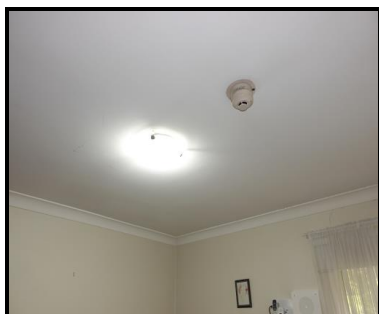
Defect ID: 200
Individual Element: Lighting - General
Defect Description: Unit 2 - Bedroom: The light fitting is approaching end of life.
Recommended Works: Replace the light fitting as part of capital renewal.
Photo No.: 01-7256
Priority: High

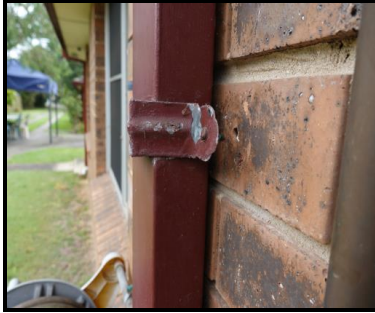
Defect ID: 134
Individual Element: Downpipe
Defect Description: Building 1 Exterior: The downpipe bracket has detached from the wall.
Recommended Works: Attach the downpipe bracket to the wall as defect rectification.
Estimated Cost: \$230.00
Photo No.: 01-7314
Priority: Low

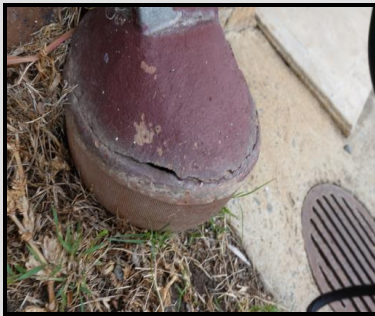
Defect ID: 132
Individual Element: Downpipe
Defect Description: Building 1 Exterior: Minor cracking has occurred at base of downpipes.
Recommended Works: Remediate damaged sections of downpipes as part of capital renewal.
Photo No.: 01-7316
Priority: Medium

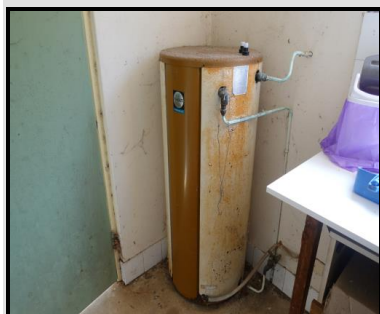
Defect ID: 196
Individual Element: Hot Water Heater
Defect Description: Laundry: The hot water heater is approaching end of life.
Recommended Works: Replace the hot water heater as part of capital renewal.
Photo No.: 01-7417
Priority: High

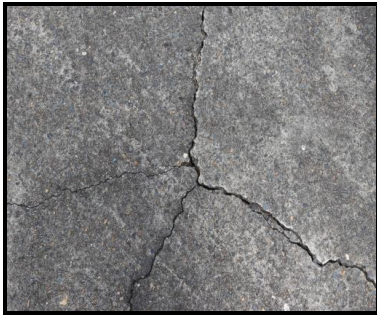
Defect ID: 135
Individual Element: Hardstand
Defect Description: External (North): Significant cracking has occurred to the hardstand surface.
Recommended Works: Remediate cracked sections of the hardstand surface as part of capital renewal.
Photo No.: 01-7407
Priority: Medium

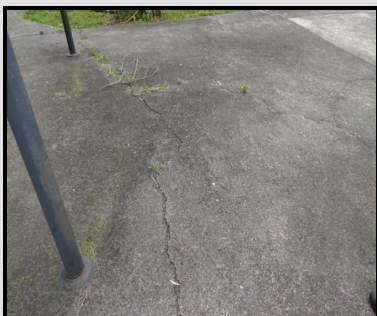
Defect ID: 122
Individual Element: Hardstand
Defect Description: External Area Between Building 1 and Building 2: Significant cracking has occurred to the hardstand surface.
Recommended Works: Remediate damaged sections of the hardstand surface as part of capital renewal.
Photo No.: 01-7219
Priority: Medium

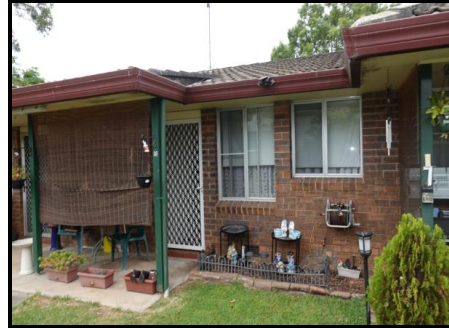
Location Photo: 01-7222

The fibre cement soffit and paint finish are in poor condition with significant deterioration, particularly on the northern side of the building. The soffit material contains asbestos therefore should be removed by a licensed contractor.

The window frames are in poor condition with significant deterioration and displacement. Sections of window frames may need to be replaced during the medium term.

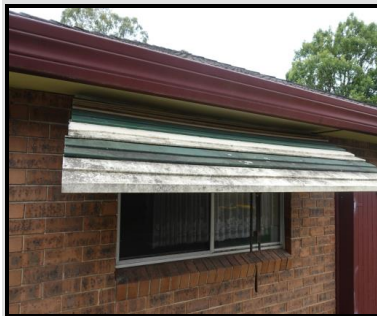
Defect ID: 123
Individual Element: Awning
Defect Description: Building 2 Exterior. Minor deterioration has occurred to the window awning structure and cover.
Recommended Works: Replace the awning structure and cover as part of capital renewal.
Photo No.: 01-7313
Priority: Medium

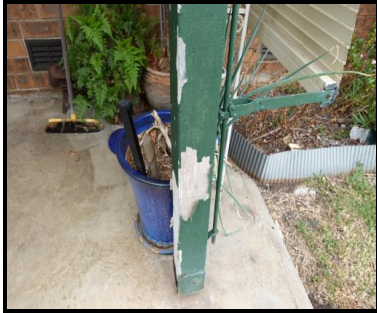
Defect ID: 129
Individual Element: Exterior Column
Defect Description: Building 2 Exterior: Significant deterioration has occurred to the column paint finish.
Recommended Works: Repaint columns as part of capital renewal.
Photo No.: 01-7305
Priority: Low

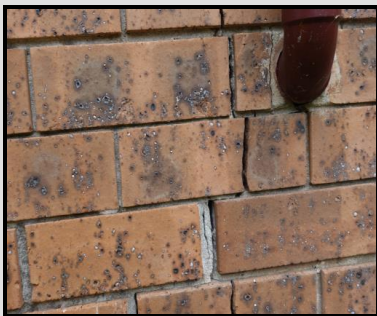
Defect ID: 131
Individual Element: Perimeter Wall
Defect Description: Building 2 Exterior: Moderate cracking has occurred to the perimeter walls.
Recommended Works: Remediate damaged sections of perimeter walls as part of capital renewal.
Photo No.: 01-7317
Priority: High

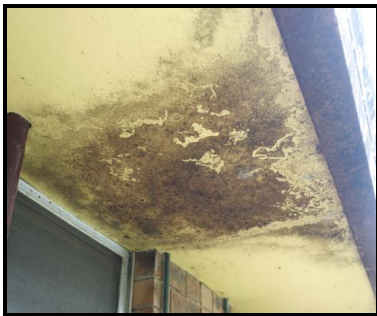
Defect ID: 130
Individual Element: Soffit
Defect Description: Building 2 Exterior South: Severe deterioration has occurred to the soffit fibre cement panels and paint finish.
Recommended Works: Replace significantly deteriorated soffit panels (by an asbestos removal licensed contractor) as part of capital renewal.
Photo No.: 01-7318
Priority: Medium

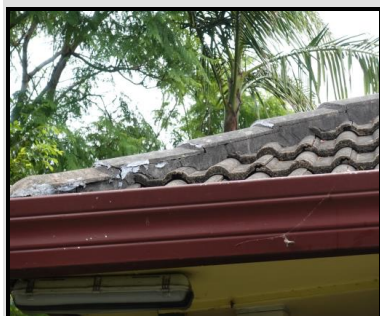
Defect ID: 126
Individual Element: Roof Cover
Defect Description: Building 2 Roof: Minor cracking has occurred to roof concrete tiles.
Recommended Works: Replace damaged roof tiles as part of capital renewal.
Photo No.: 01-7310
Priority: High

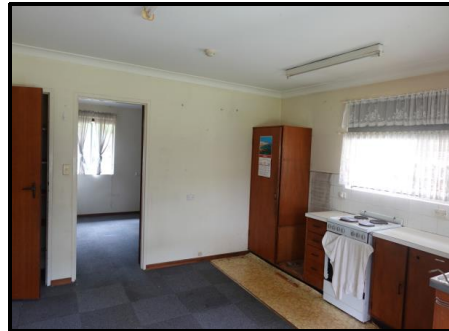
Location Photo: 01-7372

Units 6 to 11 comprise a kitchen and living area, bedroom and a bathroom. The internal construction elements include concrete floors, brick walls and plasterboard ceilings which are in fair to poor condition. Moderate damage and deterioration are evident in most units. The finishes, joinery and floor covers are generally in poor condition and will require replacement during the short term.

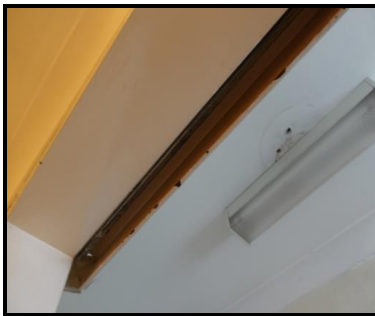
Defect ID: 184
Individual Element: Internal Door
Defect Description: Unit 10 - Bathroom: The door is not secured on the rail.
Recommended Works: Replace the door as part of capital renewal.
Photo No.: 01-7341
Priority: High

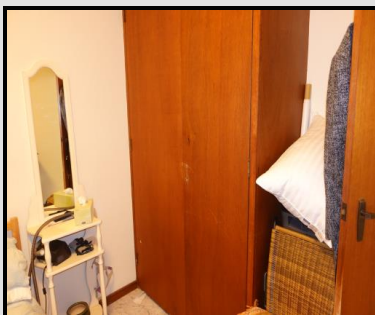
Defect ID: 186
Individual Element: Joinery
Defect Description: Unit 10 - Bedroom: The cupboard door handle has been removed.
Recommended Works: Install door handle on the cupboard as defect rectification.
Estimated Cost: \$200.00
Photo No.: 01-7331
Priority: Low

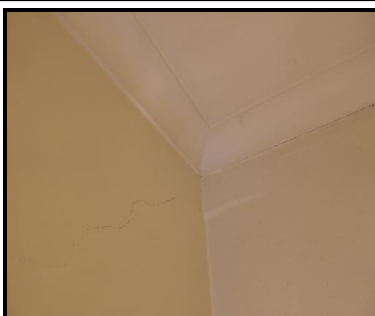
Defect ID: 182
Individual Element: Wall Construction
Defect Description: Unit 10 - Bedroom: Minor cracking has occurred to the walls.
Recommended Works: Remediate cracked sections of the walls as part of capital renewal.
Photo No.: 01-7347
Priority: Medium

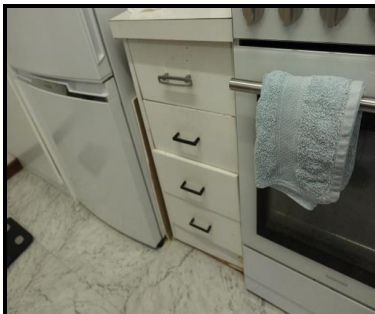
Defect ID: 183
Individual Element: Joinery
Defect Description: Unit 10 - Kitchen and Living Area: Significant deterioration has occurred to the joinery.
Recommended Works: Replace the joinery as part of capital renewal.
Photo No.: 01-7345
Priority: Medium

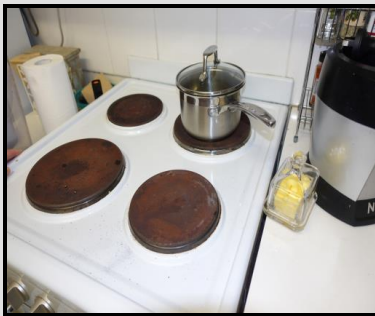
Defect ID: 180
Individual Element: Stove
Defect Description: Unit 10 - Kitchen and Living Area: Severe deterioration has occurred to the hot plates. The oven door is not correctly sealed.
Recommended Works: Replace the stove as part of capital renewal.
Photo No.: 01-7328
Priority: High

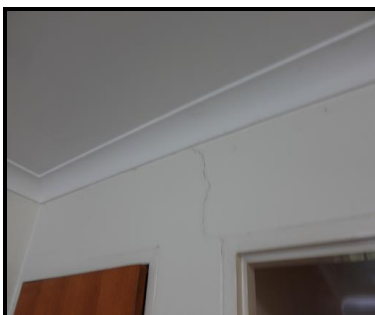
Defect ID: 181
Individual Element: Wall Construction
Defect Description: Unit 10 - Kitchen and Living Area: Minor cracking has occurred to the walls.
Recommended Works: Remediate cracked sections of the walls as part of capital renewal.
Photo No.: 01-7346
Priority: Medium

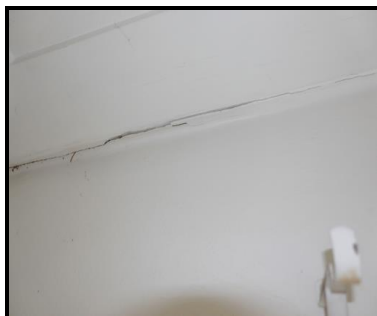
Defect ID: 192
Individual Element: Ceiling Finish
Defect Description: Unit 11 - Kitchen and Living Area: Minor deterioration has occurred to the ceiling paint finish.
Recommended Works: Repaint the ceiling as part of capital renewal.
Photo No.: 01-7404
Priority: Low

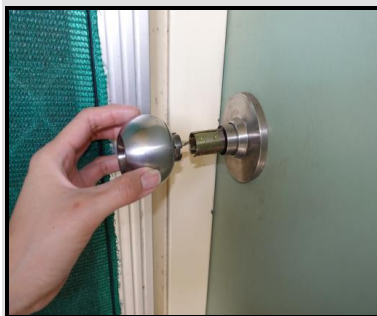
Defect ID: 194
Individual Element: Entry Door
Defect Description: Unit 11 - Entrance: The door handle is detached.
Recommended Works: Attach the door handle to the door as defect rectification.
Estimated Cost: \$380.00
Photo No.: 01-7406
Priority: High

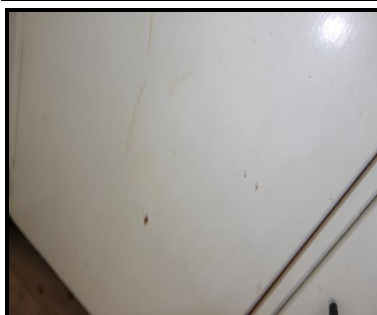
Defect ID: 191
Individual Element: Joinery
Defect Description: Unit 11 - Kitchen and Living Area: Moderate deterioration has occurred to the joinery.
Recommended Works: Replace the joinery as part of capital renewal.
Photo No.: 01-7403
Priority: Low

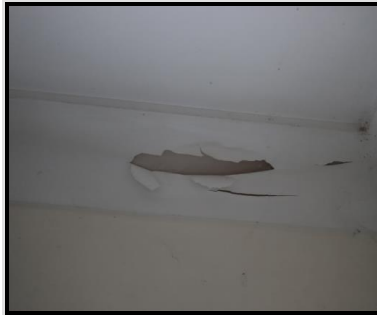
Defect ID: 166
Individual Element: Ceiling Finish
Defect Description: Unit 6 - Bathroom: Moderate deterioration has occurred to the ceiling paint finish.
Recommended Works: Repaint the ceiling as part of capital renewal.
Photo No.: 01-7383
Priority: Low

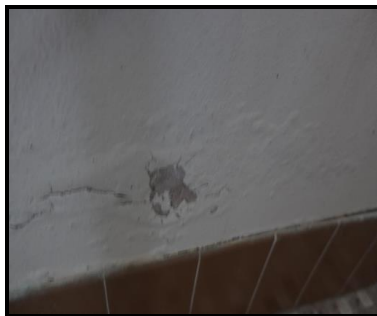
Defect ID: 162
Individual Element: Wall Finish
Defect Description: Unit 6 - Bathroom: Severe deterioration has occurred to the wall paint finish.
Recommended Works: Repaint the walls as part of capital renewal.
Photo No.: 01-7380
Priority: Low

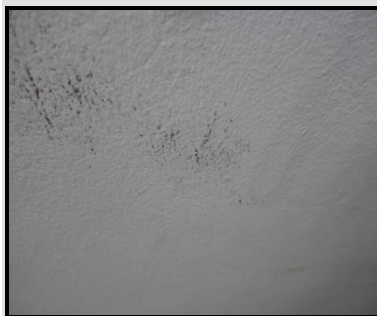
Defect ID: 161
Individual Element: Wall Finish
Defect Description: Unit 6 - Bedroom: Severe deterioration has occurred to the wall paint finish.
Recommended Works: Repaint the walls as part of capital renewal.
Photo No.: 01-7378
Priority: Low

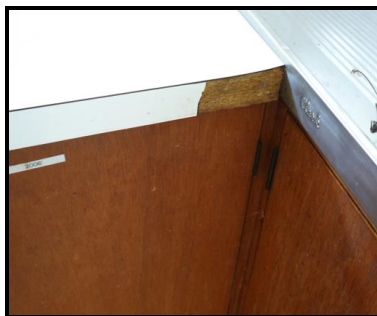
Defect ID: 163
Individual Element: Joinery
Defect Description: Unit 6 - Kitchen and Living Area: The joinery is approaching end of life.
Recommended Works: Replace the joinery as part of capital renewal.
Photo No.: 01-7384
Priority: Medium

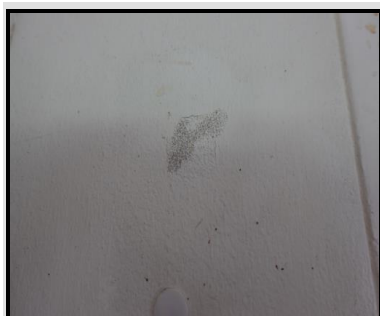
Defect ID: 160
Individual Element: Wall Finish
Defect Description: Unit 6 - Kitchen and Living Area: Severe deterioration has occurred to the wall paint finish.
Recommended Works: Repaint the walls as part of capital renewal.
Photo No.: 01-7377
Priority: Low

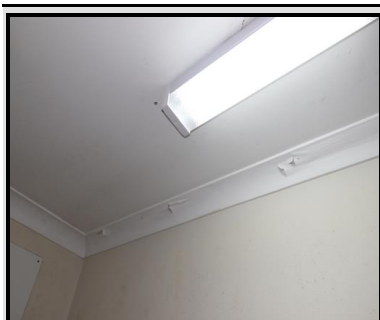
Defect ID: 169
Individual Element: Ceiling Finish
Defect Description: Unit 7 - Bathroom: Moderate deterioration has occurred to the ceiling paint finish.
Recommended Works: Repaint the ceiling as part of capital renewal.
Photo No.: 01-7260
Priority: Low

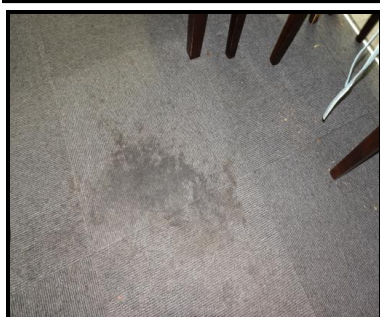
Defect ID: 171
Individual Element: Floor Cover
Defect Description: Unit 7 - Kitchen and Living Area: Moderate water damage has occurred to the floor cover.
Recommended Works: Replace the floor cover as part of capital renewal.
Photo No.: 01-7263
Priority: Medium

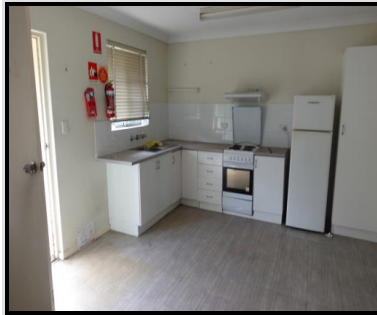
Defect ID: 167
Individual Element: Joinery
Defect Description: Unit 7 - Kitchen and Living Area: The joinery is approaching end of life.
Recommended Works: Replace the joinery as part of capital renewal.
Photo No.: 01-7354
Priority: Medium

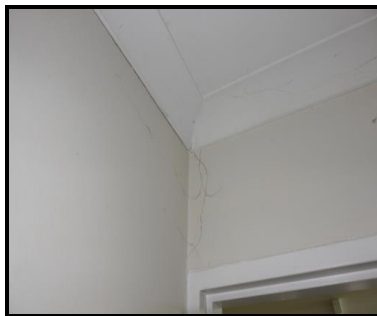
Defect ID: 170
Individual Element: Wall Construction
Defect Description: Unit 7 - Kitchen and Living Area: Minor cracking has occurred to the walls.
Recommended Works: Remediate cracked sections of the walls as part of capital renewal.
Photo No.: 01-7262
Priority: Medium

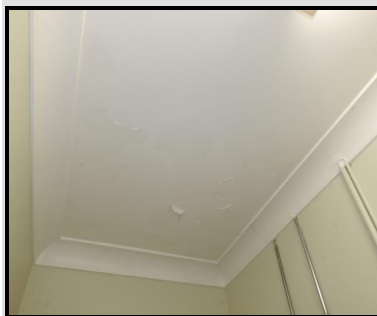
Defect ID: 173
Individual Element: Ceiling Finish
Defect Description: Unit 8 - Bathroom: Minor deterioration has occurred to the ceiling paint finish.
Recommended Works: Repaint the ceiling as part of capital renewal.
Photo No.: 01-7302
Priority: Low

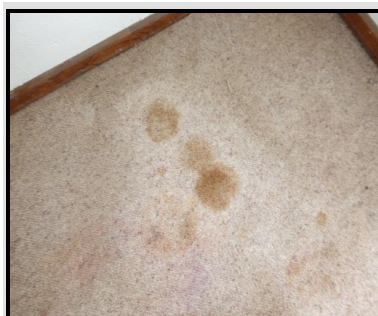
Defect ID: 175
Individual Element: Floor Cover
Defect Description: Unit 9 - Bedroom: Significant deterioration has occurred to the floor cover.
Recommended Works: Replace the floor cover as part of capital renewal.
Photo No.: 01-7396
Priority: Medium

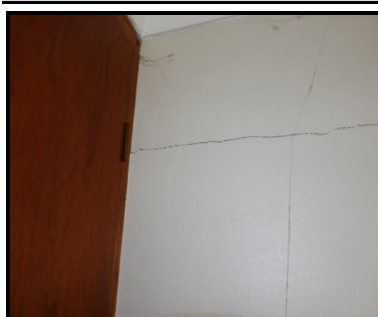
Defect ID: 177
Individual Element: Wall Construction
Defect Description: Unit 9 - Bedroom: Moderate cracking has occurred to the walls.
Recommended Works: Remediate cracked sections of the walls as part of capital renewal.
Photo No.: 01-7395
Priority: Medium

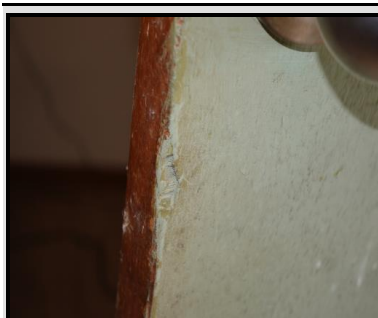
Defect ID: 178
Individual Element: Entry Door
Defect Description: Unit 9 - Entrance: Moderate deterioration has occurred to the entry door.
Recommended Works: Replace the door as part of capital renewal.
Photo No.: 01-7390
Priority: Medium

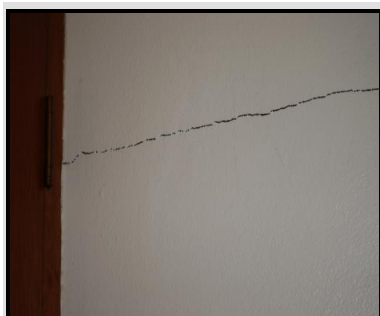
Defect ID: 174
Individual Element: Wall Construction
Defect Description: Unit 9 - Kitchen and Living Area: Moderate cracking has occurred to the walls.
Recommended Works: Remediate cracked sections of the walls as part of capital renewal.
Photo No.: 01-7391
Priority: Medium

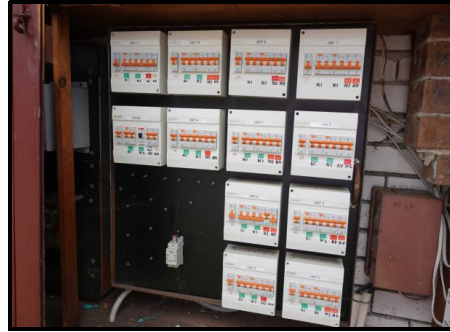
Location Photo: 01-7410

The individual switchboards which supply the units 6 to 11 are located on the western exterior perimeter wall. The panels and protection equipment are in fair condition with minor deterioration. The socket outlets are installed in appropriate locations and are in fair condition with minor deterioration.

Internal lighting is provided by a combination of fluorescent, oyster and LED light fittings. The fluorescent and oyster light fittings are approaching end of life. The LED light fittings are in good condition.

External lighting is provided by fluorescent light fittings, which are in poor condition and will require replacement during the short term.

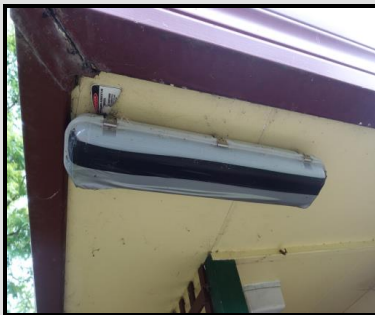
Defect ID: 127
Individual Element: Lighting - General
Defect Description: Building 2 Exterior: Light fittings are approaching end of life.
Recommended Works: Replace light fittings as part of capital renewal.
Photo No.: 01-7307
Priority: High

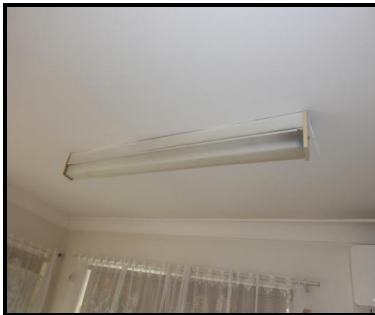
Defect ID: 193
Individual Element: Lighting - General
Defect Description: Unit 11 - Kitchen and Living Area: The light fittings are approaching end of life.
Recommended Works: Replace the light fittings as part of capital renewal.
Photo No.: 01-7405
Priority: High

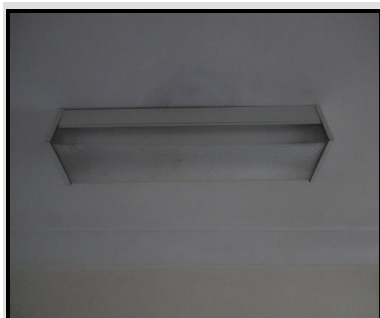
Defect ID: 165
Individual Element: Lighting - General
Defect Description: Unit 6 - Bedroom: The light fitting is approaching end of life.
Recommended Works: Replace the light fitting as part of capital renewal.
Photo No.: 01-7382
Priority: Medium

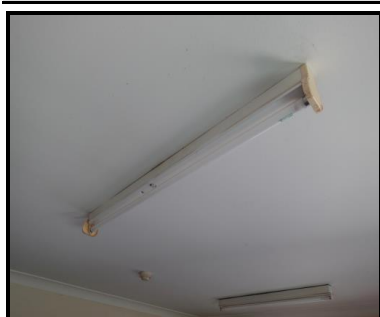
Defect ID: 164
Individual Element: Lighting - General
Defect Description: Unit 6 - Kitchen and Living Area: The light fitting is approaching end of life.
Recommended Works: Replace the light fitting as part of capital renewal.
Photo No.: 01-7381
Priority: High

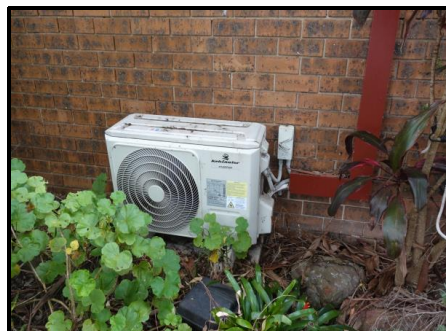
Location Photo: 01-7308

A split air conditioning system provides conditioned air to unit 11. The air conditioning condenser and evaporator units are in fair condition with minor deterioration.

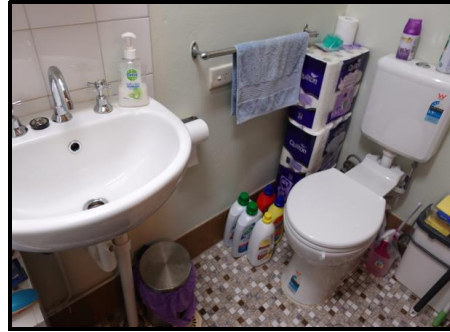
Location Photo: 01-7304

The sewer system effectively discharge waste from the building. The sewer system pipework, bathroom cisterns and pans are in fair condition.

The stormwater system discharge rainwater from the roof. The gutters, downpipes and underground stormwater drainage system pipework are in fair condition.

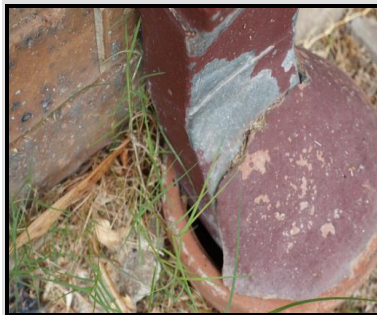
Defect ID: 125
Individual Element: Downpipe
Defect Description: Building 2 Exterior: Moderate damage has occurred to the connection between downpipes and stormwater system.
Recommended Works: Remediate damaged connection between downpipes and stormwater system as part of capital renewal.
Photo No.: 01-7311
Priority: Medium

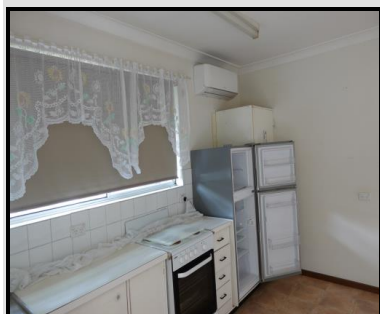
Defect ID: 188
Individual Element: Internal Pipework Hot Water System
Defect Description: Unit 11 - Kitchen and Living Area: The hot water pressure is insufficient.
Recommended Works: Drain the hot water system and rectify the cause of insufficient water pressure as defect rectification.
Estimated Cost: \$590.00
Photo No.: 01-7397
Priority: Medium

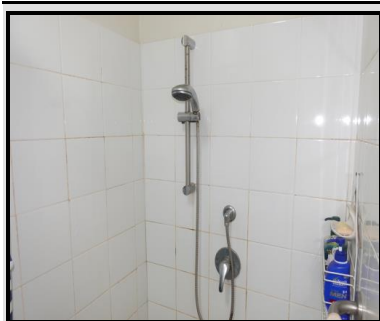
Defect ID: 168
Individual Element: Shower
Defect Description: Unit 7 - Bathroom: Moderate corrosion has occurred to the shower fitting.
Recommended Works: Replace the shower fitting as part of capital renewal.
Photo No.: 01-7259
Priority: Medium

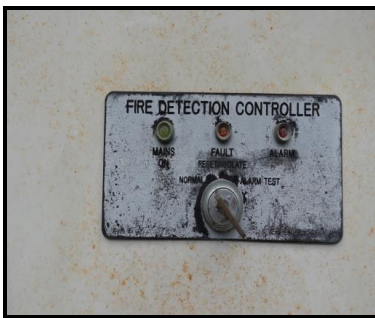
Defect ID: 185
Individual Element: Fire Panel
Defect Description: Building 2 Exterior: The panel does not identify the unit that activated the system alarm.
Recommended Works: Upgrade the fire panel so that the panel displays the unit that activated the system alarm as part of capital renewal.
Photo No.: 01-7348
Priority: High

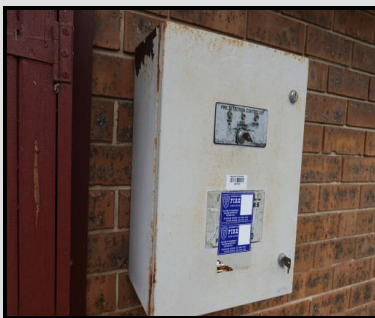
Defect ID: 124
Individual Element: Fire Panel
Defect Description: Building 2 Exterior: Significant corrosion has occurred to the fire panel.
Recommended Works: Upgrade the fire panel as part of capital renewal.
Photo No.: 01-7312
Priority: High

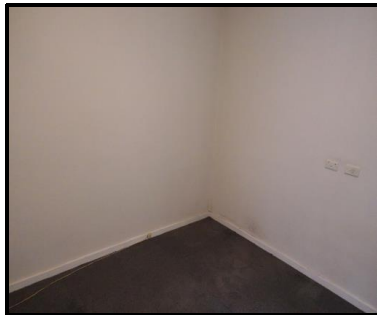
Non-Compliance ID:	100
NCC Section:	Performance Provisions
NCC Part:	Health and Amenity
Individual Element:	Construction Properties
Description:	Unit 5 - Bedroom: Minor mould growth was identified on the wall.
Recommended Works:	Remove mould from the wall as defect rectification.
Estimated Cost:	\$430.00
Photo No.:	01-7366
Priority:	Medium
Obligation:	Mandatory

Minor mould growth was identified in the unit 5 bedroom and should be removed during the short term.

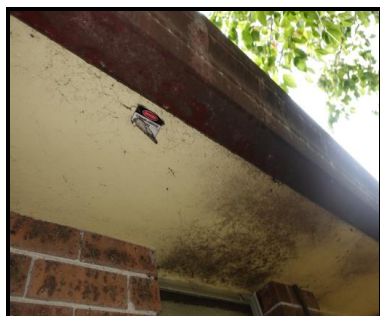
Non-Compliance ID:	99
NCC Section:	Work Health and Safety
NCC Part:	Safety Provisions
Individual Element:	Construction Properties
Description:	Building 1 Exterior: The soffit underpanels contain asbestos.
Recommended Works:	Remove asbestos containing materials by a licensed contractor in conjunction with capital renewal (refer LCC Plan).
Photo No.:	01-7196
Priority:	High
Obligation:	Mandatory

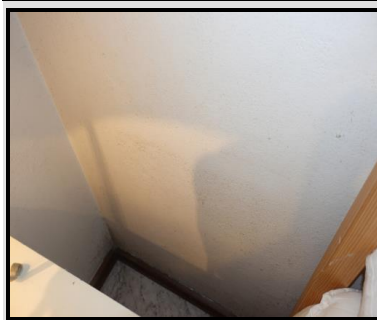
Non-Compliance ID:	102
NCC Section:	Performance Provisions
NCC Part:	Health and Amenity
Individual Element:	Construction Properties
Description:	Unit 10 - Bedroom: Minor mould growth was identified on the wall.
Recommended Works:	Remove mould from the wall as defect rectification.
Estimated Cost:	\$390.00
Photo No.:	01-7340
Priority:	Medium
Obligation:	Mandatory

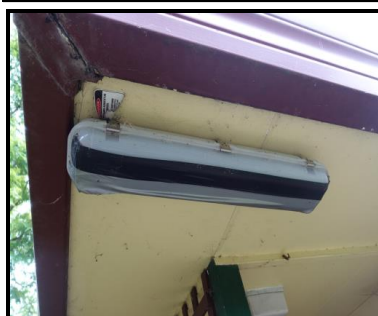
Non-Compliance ID: 103
NCC Section: Work Health and Safety
NCC Part: Safety Provisions
Individual Element: Construction Properties
Description: Building 2 Exterior: The soffit underpanels contain asbestos.
Recommended Works: Remove asbestos containing materials by a licensed contractor in conjunction with capital renewal (refer LCC Plan).
Photo No.: 01-7307
Priority: High
Obligation: Mandatory
